JOHNSON COUNTY DAM A-26

JOHNSON COUNTY, MISSOURI

MO 20073

PHASE 1 INSPECTION REPORT NATIONAL DAM SAFETY PROGRAM

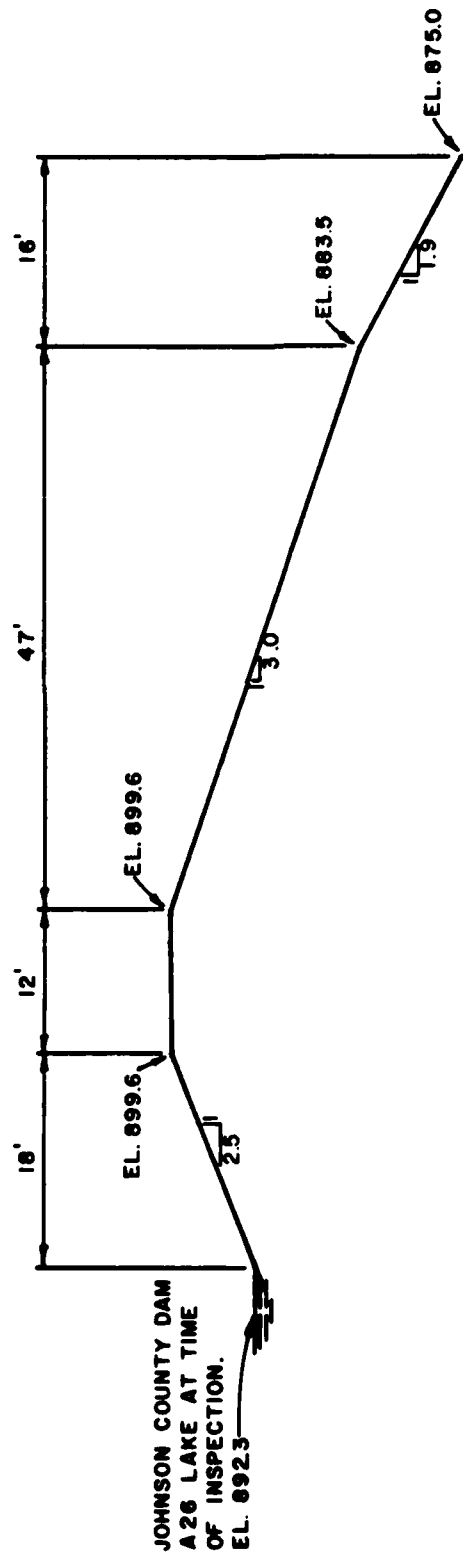
JOHNSON COUNTY DAM A-26 DAM CROSS SECTION

NOTE:
CROSS SECTION TAKEN
NEAR STATION 5+90

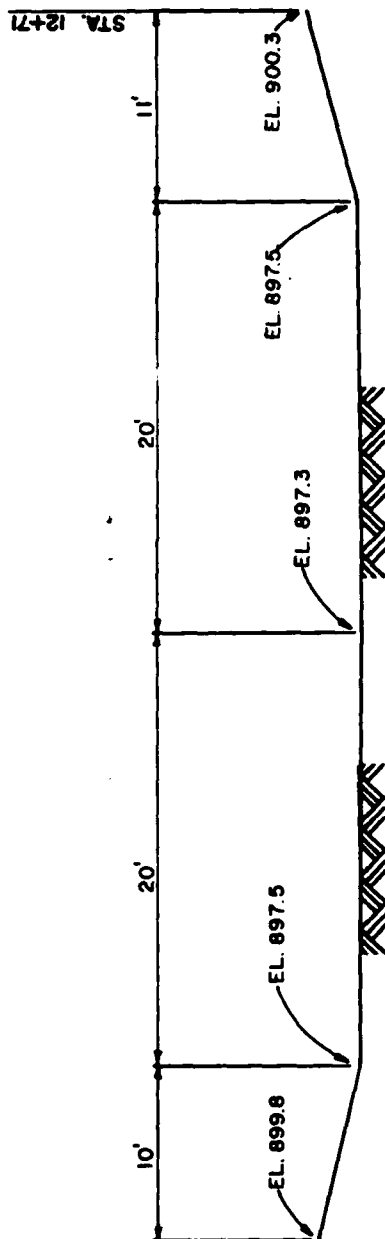
JOHNSON COUNTY DAM A-26 EMERGENCY SPILLWAY CROSS SECTION

NOTE: CROSS SECTION TAKEN
BETWEEN STATIONS 12+10
& 12+71 ALONG C. OF DAM
LOOKING DOWNSTREAM
